NASA TN D-6721

APOLLO EXPERIENCE REPORT - WINDOW CONTAMINATION

by L. J. Leger and R. W. Bricker

Manned Spacecraft Center

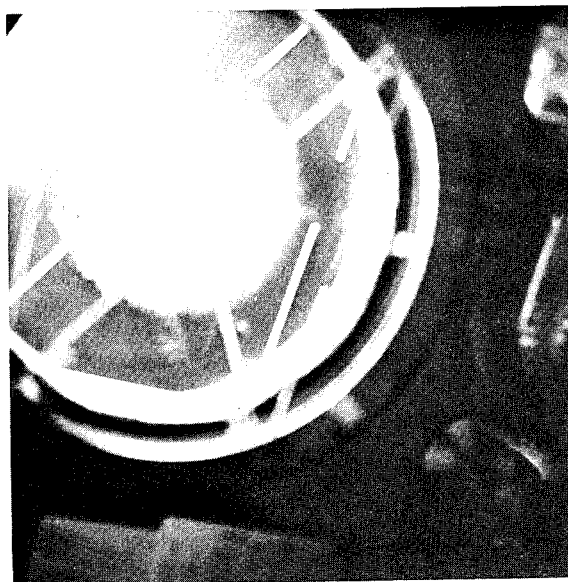
Soon after earth-orbital insertion, a film appeared on surfaces 2 and 3 of the hatch and side windows of the Apollo 7 and 8 command modules. This contamination continued to accumulate during flight and resulted in a heavy film in some locations and droplet formation in other locations. A photograph, taken with a camera focused on the hatch window during the Apollo 7 mission, is shown in figure 7. During the night pass of the spacecraft in earth orbit and during other similar cold-window conditions, the contamination seemed to crystallize and become opaque, particularly on the hatch window.

Figure 7. - Apollo 7 inflight hatch-window contamination.

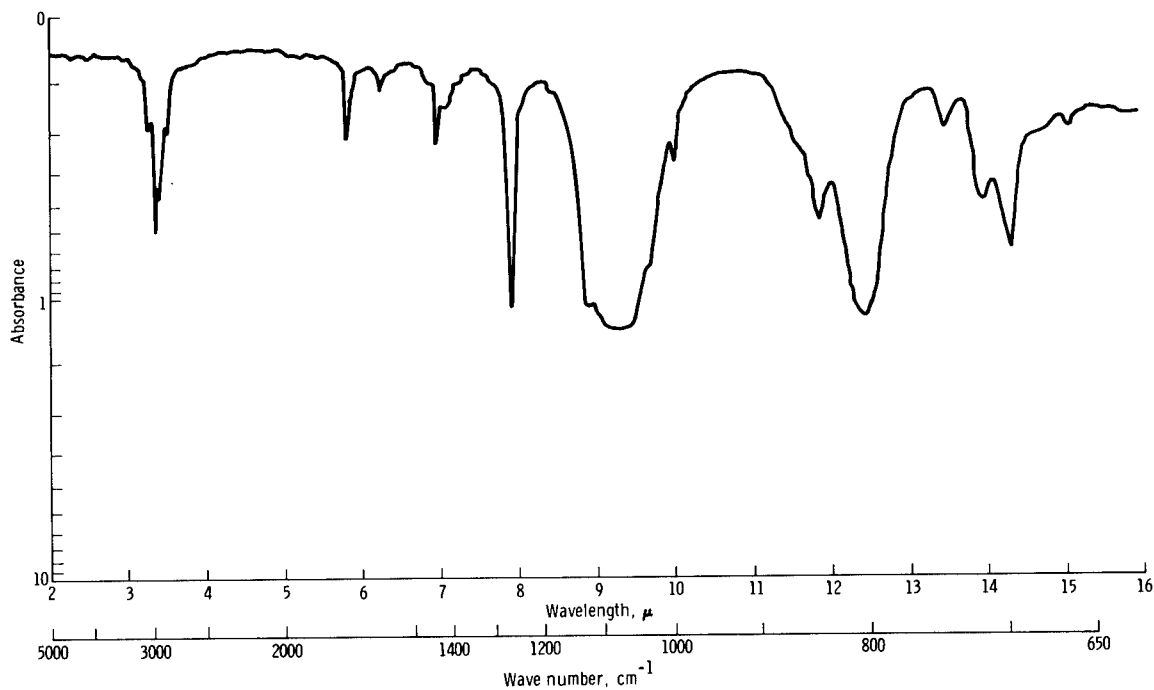
The infrared spectra of contamination collected from surfaces 2 and 3 on the windows of the Apollo 7 and 8 spacecraft were typical of organosilicon high-molecular-weight compounds. A representative spectrum of this contamination is shown in figure 8; the spectrum contains absorption bands common to the methyl-phenyl silicone structure. The same type of contamination was identified on the window of an Apollo CM (2TV-1) that was used for thermal-vacuum testing at the NASA Manned Spacecraft Center.

Figure 8. - Typical infrared spectrum of contaminations from surfaces 2 and 3 on the Apollo 7 and 8 CM's.

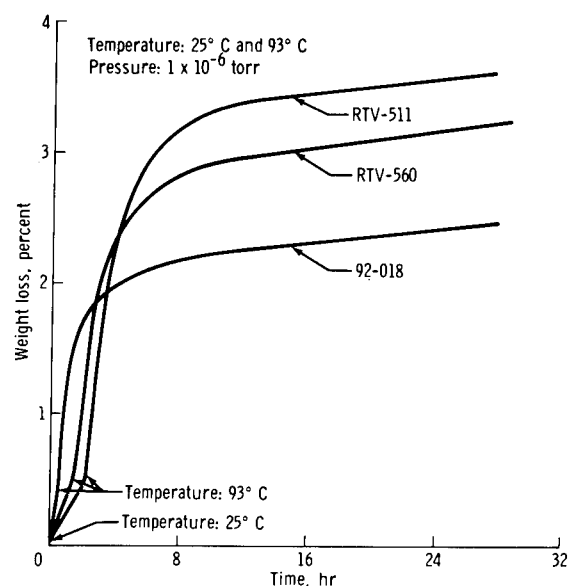
Isothermal-vacuum weight loss of the problem materials was determined by use of a continuous-recording vacuum balance. The vacuum weight loss of these materials at 93° C is shown in figure 9. This temperature was the maximum temperature expected in flight for materials that were used in the window area. Samples of all three materials had large initial weight-loss rates (approximately 1.25 percent/hr) that subsequently, after 15 hours, decreased to a much smaller rate (approximately 0.01 percent/hr).

Figure 9. - Vacuum weight loss of window materials that caused contamination on surfaces 2 and 3.

Because the weight-loss rates for the problem materials were small after exposure to vacuum at elevated temperatures, an apparent solution to the silicone-outgassing problem was to bake the manufactured parts in a vacuum before installation in the spacecraft. This process was used with success in reducing the Gemini window contamination (ref. 3). In applying a vacuum bake, it is desirable to use as high a temperature as possible in the thermal-vacuum exposure. However, at high temperatures (approximately 250° C), polymer degradation is possible. Therefore, a temperature of 205° C was chosen as the maximum allowed in the vacuum bake. At this temperature, the weight loss levels off (fig. 10). This condition indicates no major thermally induced polymer degradation has occurred.

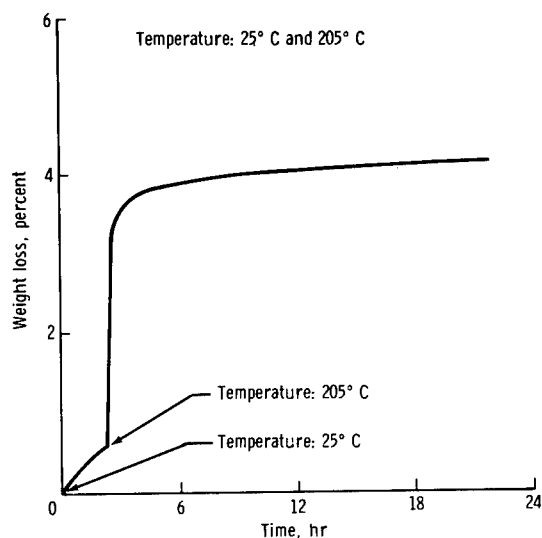
Figure 10.- Vacuum weight loss of RTV-560 at temperatures used in the manufacturing process at 1×10^{-6} torr.

Further considerations of the corrective action indicated that the vacuum bake should be conducted at low pressures and for long periods of time. However, because of limited chamber availability, a maximum pressure of 1×10^{-1} torr was allowed, and an exposure time of 1.72×10^5 seconds (48 hours), divided into two 8.64×10^4 -second (24 hours) steps, was used. The weight loss during and after exposure of the materials

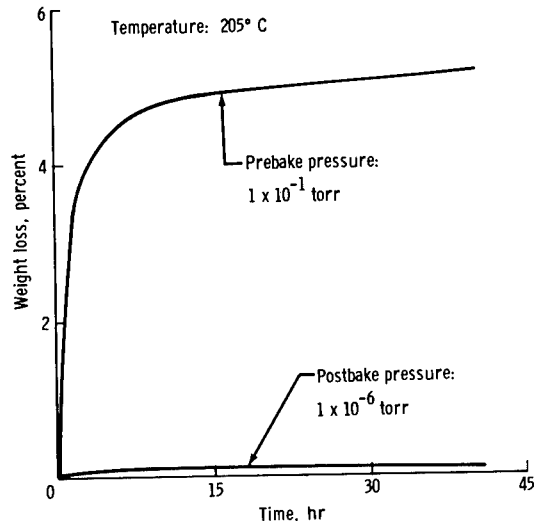
Figure 11.- Vacuum weight loss of RTV-560 for manufacturing cycle simulation.

to a vacuum of 1×10^{-1} torr at 205°C is shown in figure 11. Because the total weight loss after the vacuum bake is small (approximately 0.08 percent) and because only a small amount (approximately 0.008 percent) of this weight loss is condensable material at 25°C , a vacuum bake at the conditions selected (1×10^{-1} torr for two 8.64×10^4 -second periods) was considered adequate to prevent contamination of the spacecraft windows.

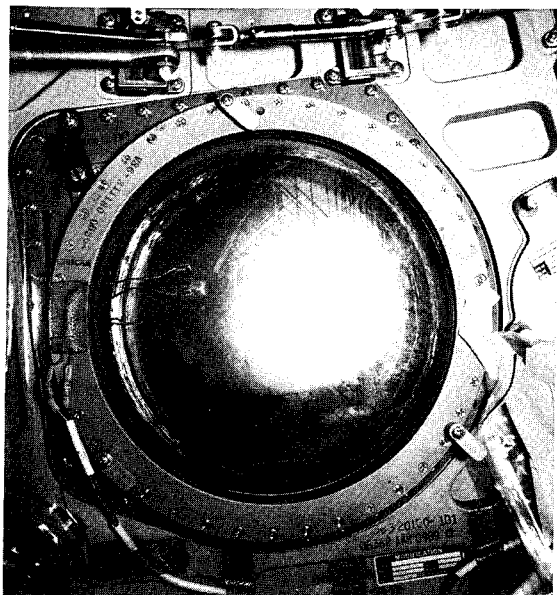
Figure 12. - Hatch window of 2TV-1.

During the maximum heating conditions of the test, the maximum temperature that was measured for the nonmetallic materials was 87°C , whereas the temperature of surface 2 of the hatch window attained -20°C in the cold conditions of the test. A small amount of contamination was noticed during a short portion of the first cold-soak period of the hatch test. The contamination disappeared early in the first heating cycle and did not reappear. This phenomenon had been noticed in earlier tests and was attributed to water vapor trapped between the heat shield and the pressure-vessel structure. Post-test infrared analysis of the hatch-window surfaces indicated no detectable contamination.

To verify that vacuum baking was an adequate solution for full-scale windows, an Apollo hatch was assembled from baked components and was tested in a large vacuum chamber. Heating was provided by a solar lamp and supplemental infrared heaters. The hatch was tested under simulated earth-orbital thermal conditions and under conditions of maximum heating that may be encountered in a maneuver such as an attitude hold for docking purposes.

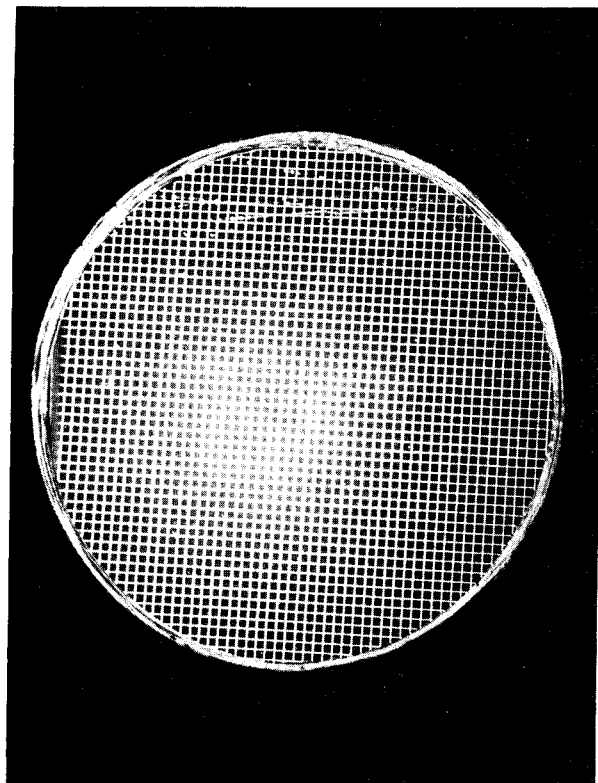
Figure 13. - Apollo 9 hatch window.

Crewmember reports and the postflight examination did not indicate any contamination problems on the windows made of baked parts. The rendezvous windows, however, were contaminated slightly. This problem did not cause major concern because subsequent flights would involve the use of baked parts for all windows. A photograph (fig. 12) of the hatch window of 2TV-1 (a test vehicle that revealed window contamination similar to that found on the Apollo 6, 7, and 8 flights) is compared with a grid photograph (fig. 13) of the Apollo 9 hatch window after recovery. In figure 13, the grid, which is behind the window assembly, is shown clearly. Conversely, large amounts of contamination over the entire window are shown in figure 12. In this photograph, condensation of the contamination had accumulated to such an extent that droplet streaks were detectable. Although the photographs were not taken under the same conditions (the 2TV-1 photograph had no grid), they both indicate that a significant improvement was obtained by the use of vacuum-baked parts.

The Apollo 9 mission was the first flight on which vacuum-baked parts were used. The rendezvous windows had no contamination problems on earlier flights; therefore, it was decided to use baked parts only on the hatch and side windows.
